Loss of Direction

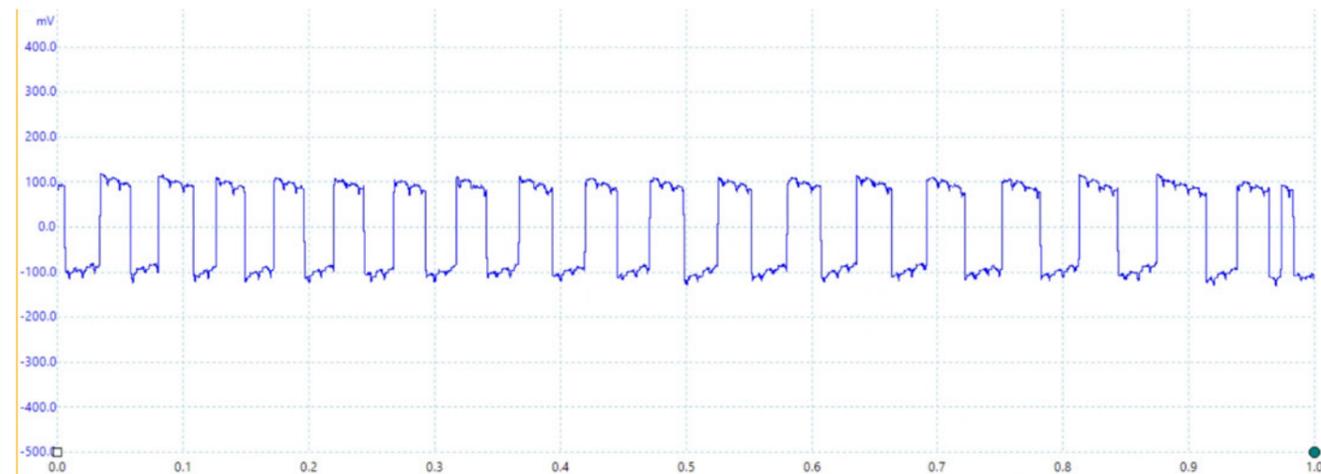
Figure 1

With the vehicle returned to the workshop, an oscilloscope was connected to the left rear wheel speed sensor to check the integrity of the signal in order to see if this was a simple case of a faulty sensor. On checking the signal, there was an inconsistency in the square wave signal. (Fig.1)

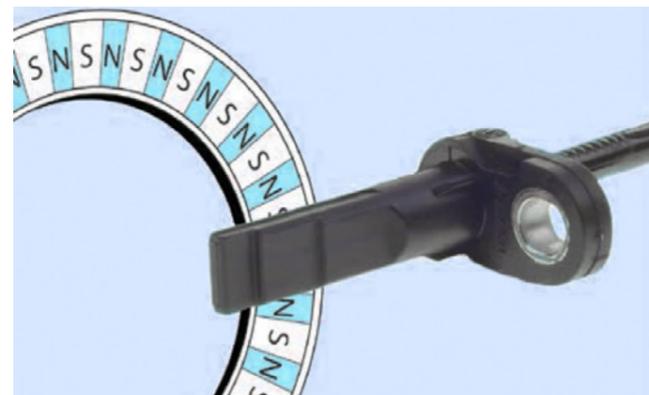
Figure 2

The wheel speed sensor is mounted in the hub at right angles to the magnetised impulse reluctor ring, which is mounted on the wheel bearing assembly. The active wheel speed sensor makes use of the magnetic resistive effect; a magnet in the sensor produces a magnetic field with the lines of magnetic flux running at right angles to the sensor layer. Deflection of the lines by the impulse wheel causes changes in resistance in the thin ferromagnetic layer of the sensor element. (Fig.2)

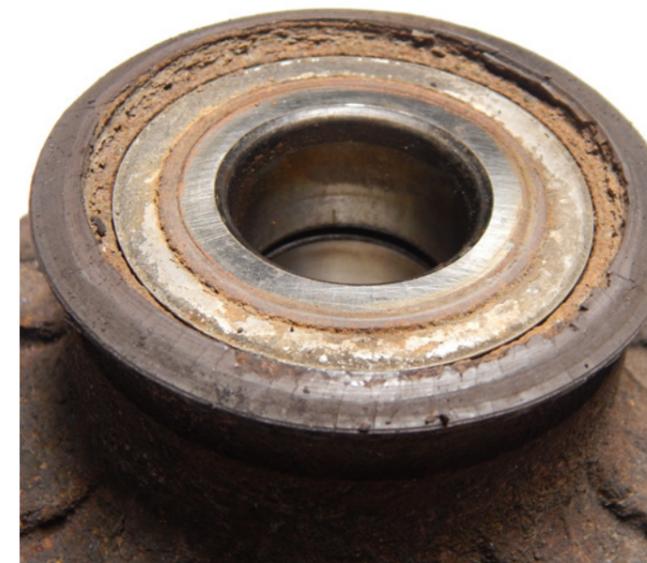
Figure 3

With the wheel bearing assembly removed from the stub axle, it became obvious what had been causing the issue. Corrosion between the ferrous metal of the wheel hub and the magnetic reluctor ring had caused distortion to the reluctor, causing cracking of the magnetic ring and a narrowing of the air gap between the reluctor and the wheel speed sensor. This was the primary fault with the vehicle. (Fig.3)

The febi wheel bearing kit (23320) was required as the replacement part, along with a wheel speed sensor (23810), because it had sustained some light damage from the distorted reluctor ring.
